# Excavations in the Latin Chapel and outside the east end of Oxford Cathedral, 1962/3

by DAVID STURDY

## SUMMARY

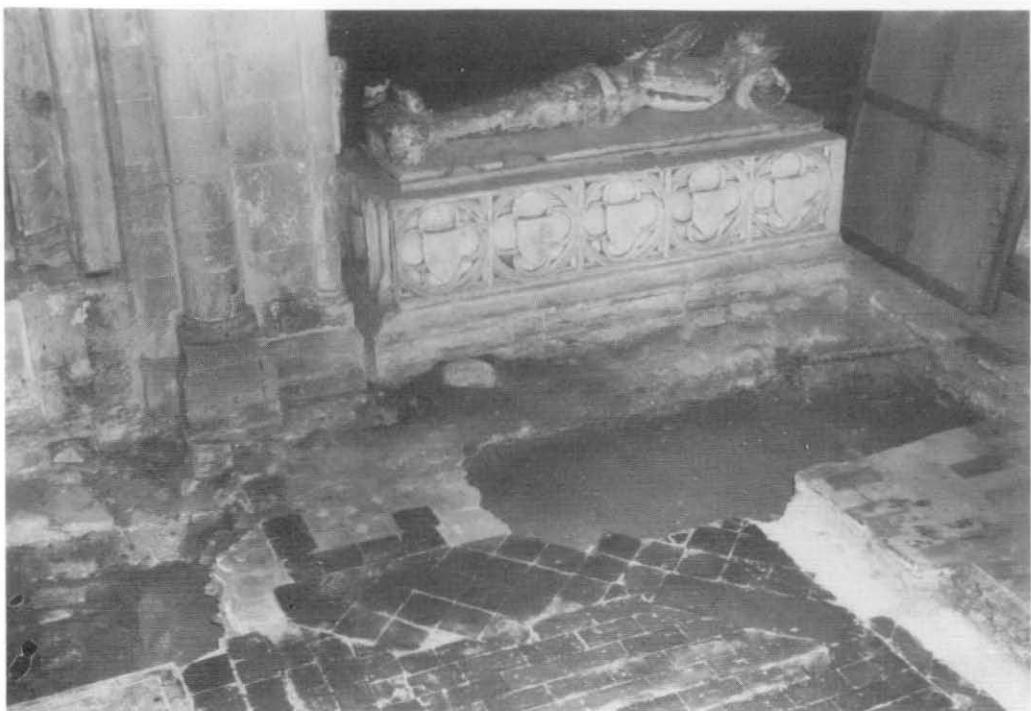
Fig. 34. Latin Chapel, looking S.W. towards Nowers monument, before removal of tile floor.

In 1963 the old floor of the Latin Chapel (Fig. 34), of red tiles and bricks set in mortar with some stone and marble slabs, was replaced by a stone floor laid on concrete. The new floor was designed by Mr. S.E. Dykes Bower as adviser for a larger scheme, initiated by the then Dean, the Very Revd. C.A. Simpson, to 'clean up' the Cathedral. Unable to avert the destruction of the old floor, in fact a much-altered and badly-worn medieval tile floor unrecognised by any previous scholar, we recorded it in detail and then excavated beneath it. Unfortunately the medieval stalls were not studied or recorded during removal. Generally presumed to have been the main choir-stalls, ejected to the Latin Chapel in the early 17th century, they were replaced after over-restoration. Volunteers from the Ashmole Club, the Oxford University Archaeological Society and elsewhere excavated Cuttings 1–3 within the chapel throughout the winter of 1963.<sup>1</sup> The Department of Antiquities, Ashmolean Museum, lent tools and equipment, and the writer paid all expenses of the work.

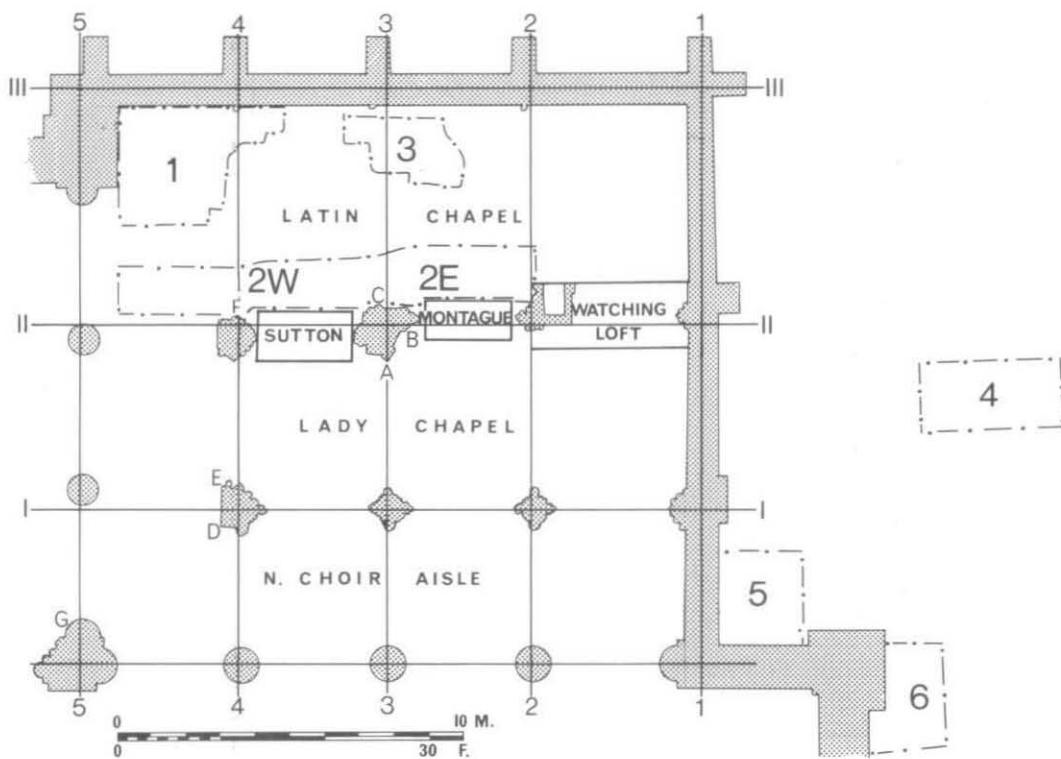
Fig. 35. The N.E. chapels, showing the locations of the 1962–3 trenches and the pier numbering system used in this and other papers.

Layers and soil-deposits are numbered, structural features lettered. The excavation was measured in feet and inches, here converted into metric. The different cuttings are expressed in bold type (e.g. **6**), the various structures as A to K and layers as 1 to 12. Piers are referred to by the numbering system shown on Fig. 35.

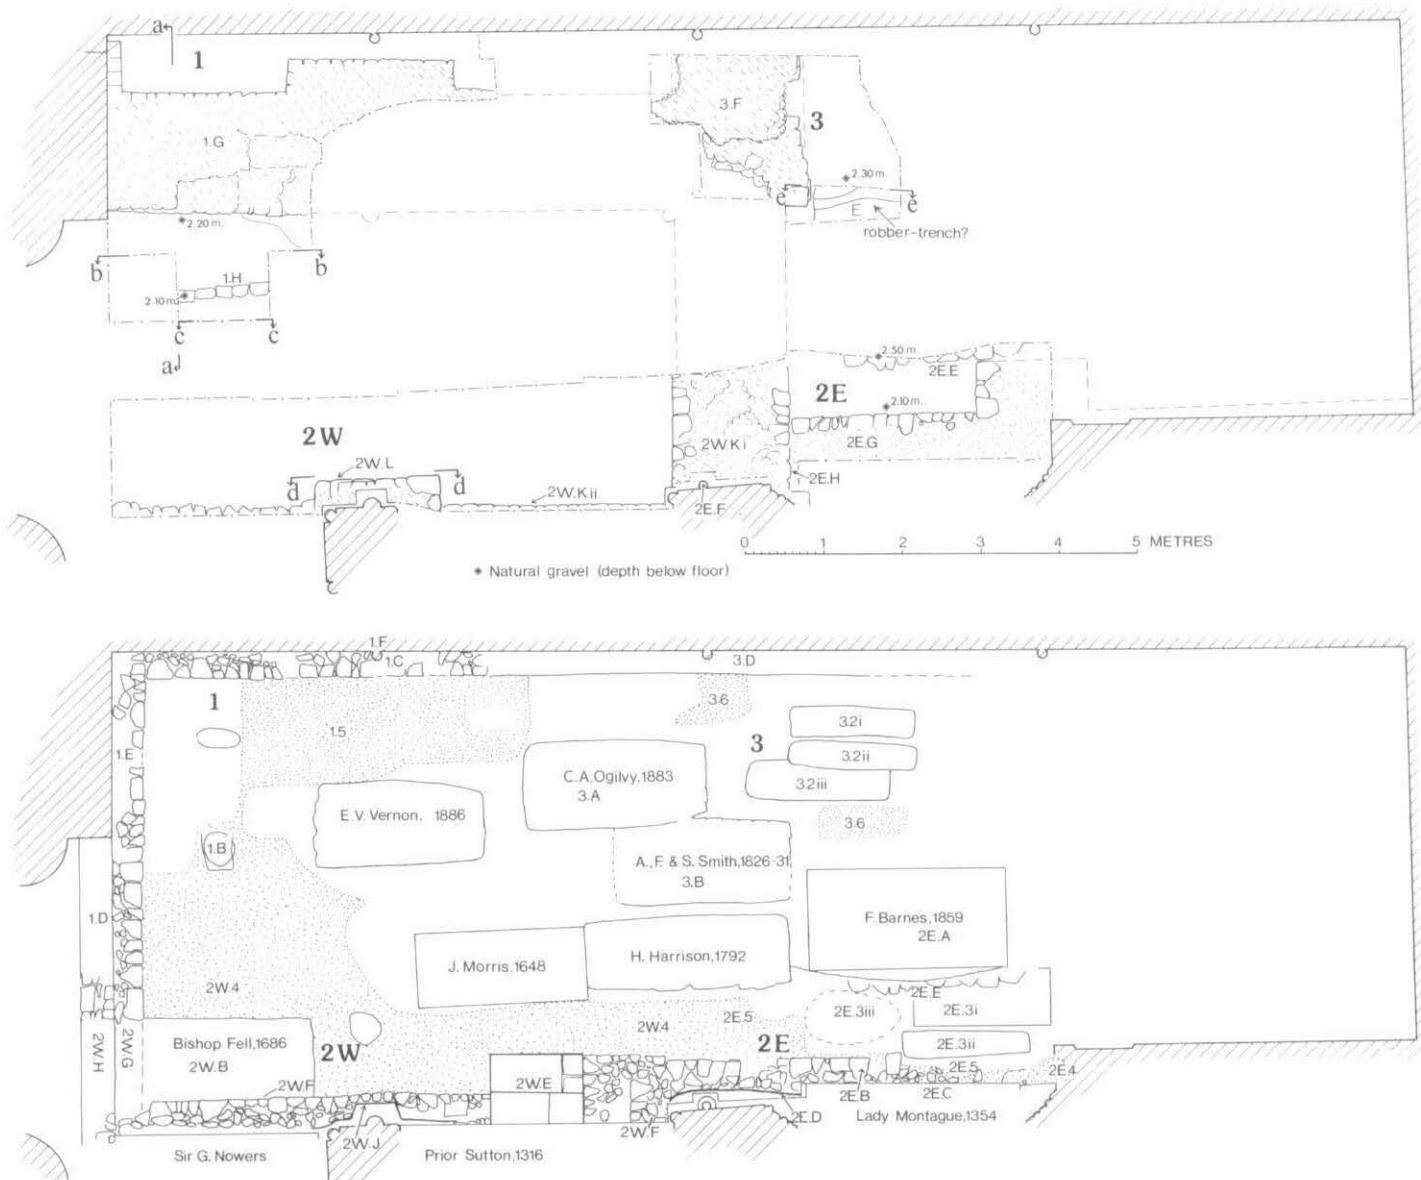
Fig. 36. Latin Chapel: excavation plans. *Above:* earlier features; *below:* later features. (Re-drawn by John Blair.)

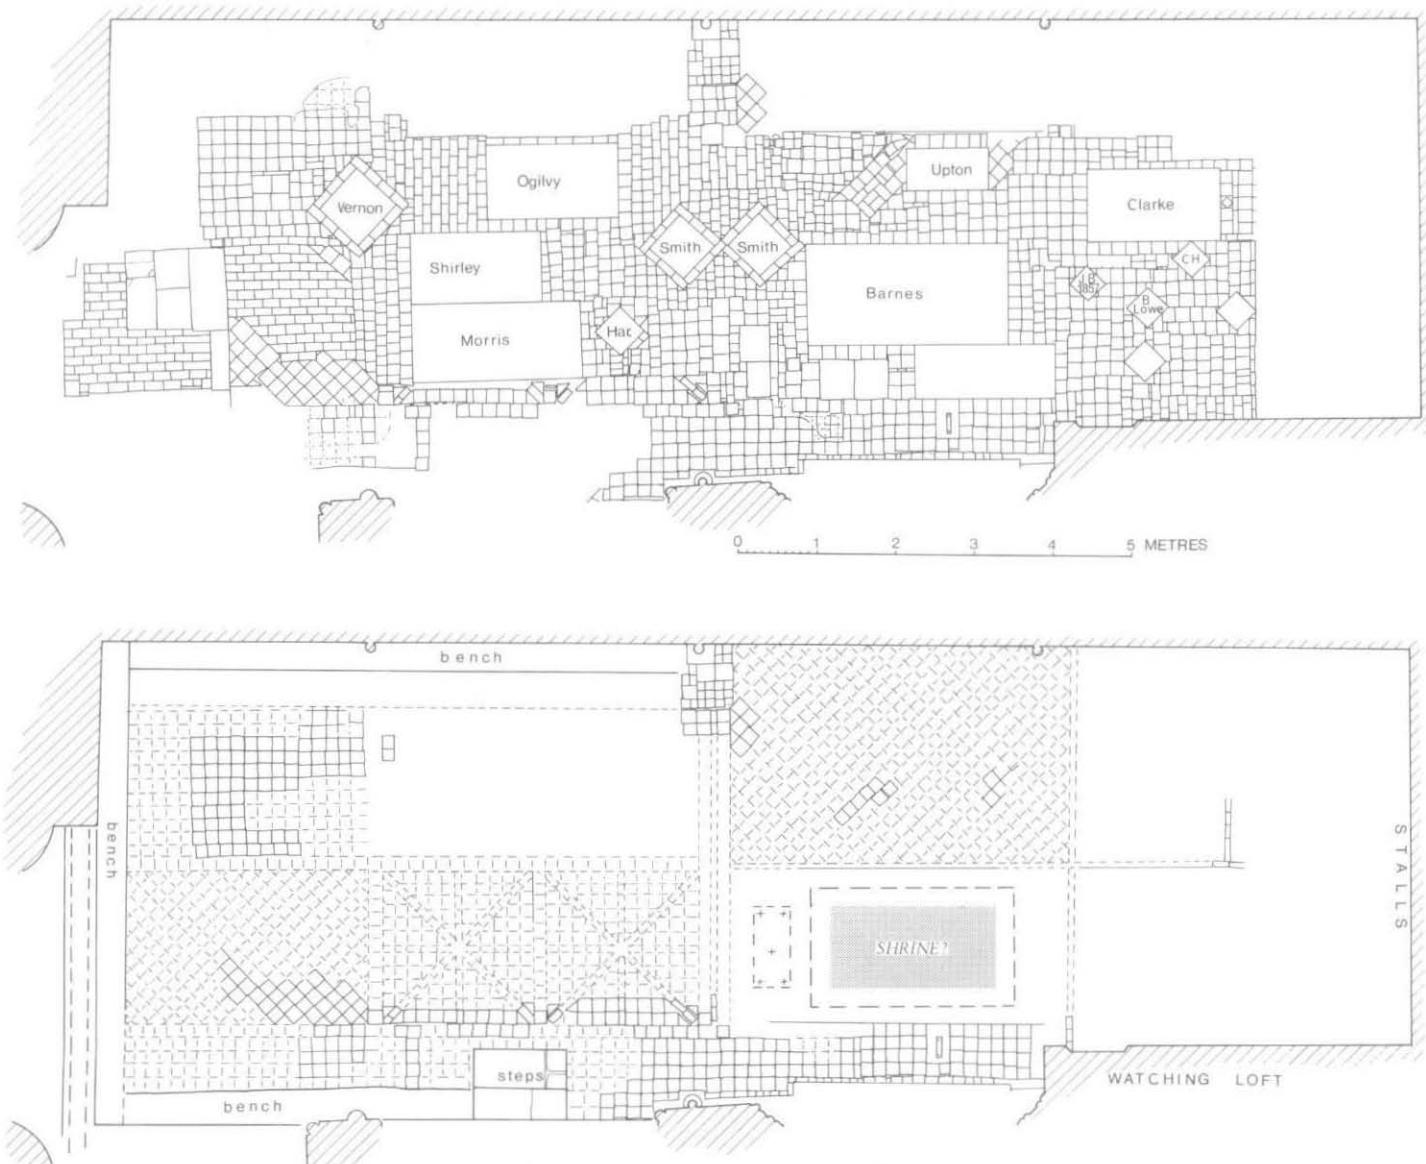
Fig. 37. Latin Chapel: latest tile floor. *Above:* as existing 1962; *below:* proposed reconstruction of design c.1500. (Re-drawn by John Blair.)

rebuilt the cloister (above, p. 66 and below, pp. 188–91) and refectory,<sup>21</sup> the floor of the Latin Chapel was relaid in tiles. The tiles of an older, 14th-century, floor which lay 42–43 cm. below the general level of the church floor (above, p. 76) were lifted, none of them being found in position, apart from a few (p. 84), which had been buried long before beneath the S. wall-bench of the chapel. Some late 13th- and 14th-century tiles were evidently used in the new floor (below, p. 109). To bring the new floor-level up to only 15 cm. below the general level, gravelly loam, mortar and rubble were brought in, perhaps from a simultaneous *lowering* of the floor-levels of the present Lady Chapel just to the S. The new floor was laid over this dumped material, which also contained broken tiles from the old floor and some casualties smashed during delivery. In 1963 well over 300 tiles still remained in position, or survived as impressions in the mortar-bedding. The new floor must have comprised more than 2000 tiles, so that enough remained to make a fairly certain reconstruction of the original design (Fig. 37), discussed section by section below.

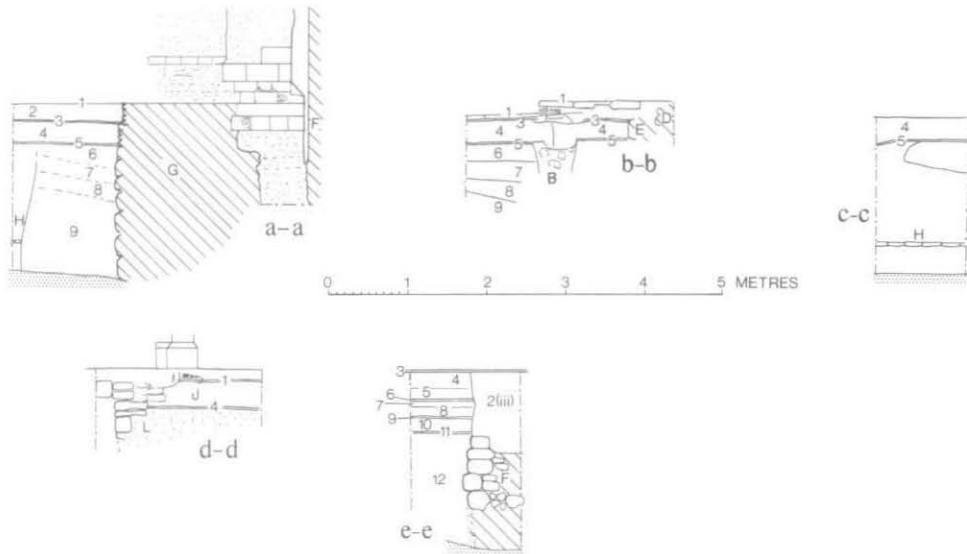
Fig. 38. Latin Chapel: sections. Letters correspond with section lines on Fig. 36, upper. (Re-drawn by John Blair.)

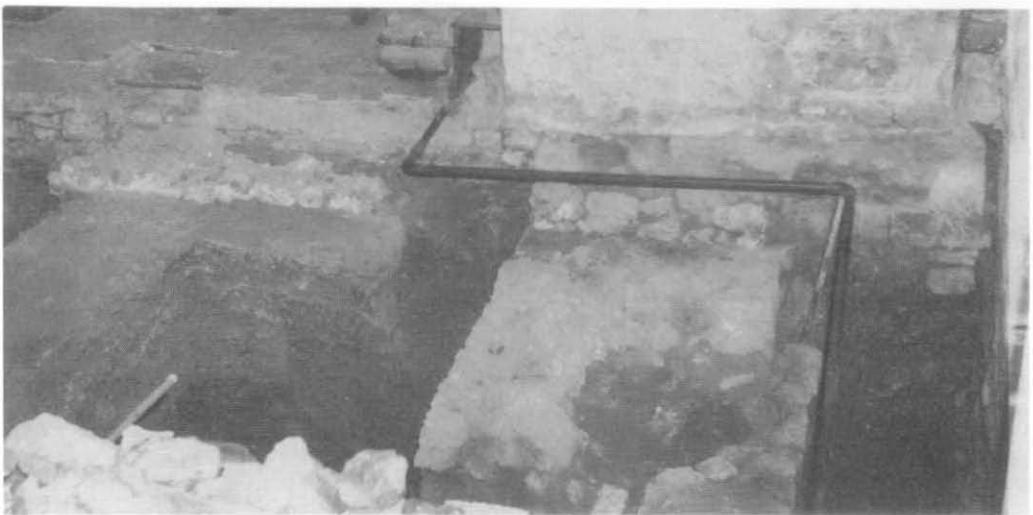
Fig. 39. Cutting 1, looking westwards along footing of N. wall of 'pre-Latin' chapel (1.G) towards E. face of original buttress at N.E. corner of N. transept.

- G. The rubble foundations of a small, two-bay, chapel of the 12th century, 1.50 m. wide, thickening to 2.30 m. for the transept buttress (Fig. 39) and to 1.95 m. for the central buttress of the N. wall. On its S. face, the footing is 2.30 m. deep, trench-built below 85–115 cm. Against the transept buttress it could be seen to have been face-built with an offset of 7–8 cm. at a depth of 45 cm., while on the N. face there was a wider offset of 15–19 cm. which showed that the alignment of this part of the church had been corrected by about five degrees anti-clockwise when the walls were set out.

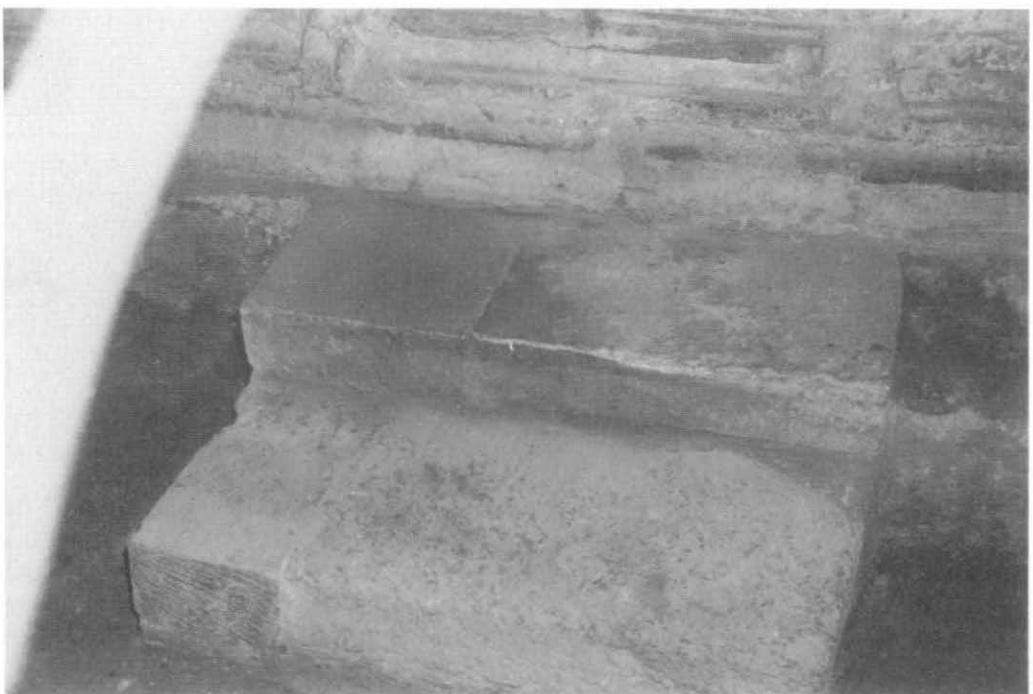
Fig. 40. Steps down from Lady Chapel into Latin Chapel (2W.E), looking S.

- 2. Loose gravelly loam and mortar with broken floor-tiles and 14th- to 15th-century pottery and glass.
- E. Two stone steps (1.15 cm. wide) with a plaster-faced rubble blocking (60 cm. wide) on the E. side of the steps, which led down into the chapel to the floor at Layer 3 (Fig. 40). The lower step had no doubt been covered by the main tiled floor 1, which must have abutted on the upper step. Enthusiastic undergraduate diggers unfortunately removed the tiles or bedding here before the late-medieval date of the floor was appreciated. This entrance into the chapel succeeded an earlier one through the western bay (see J below).

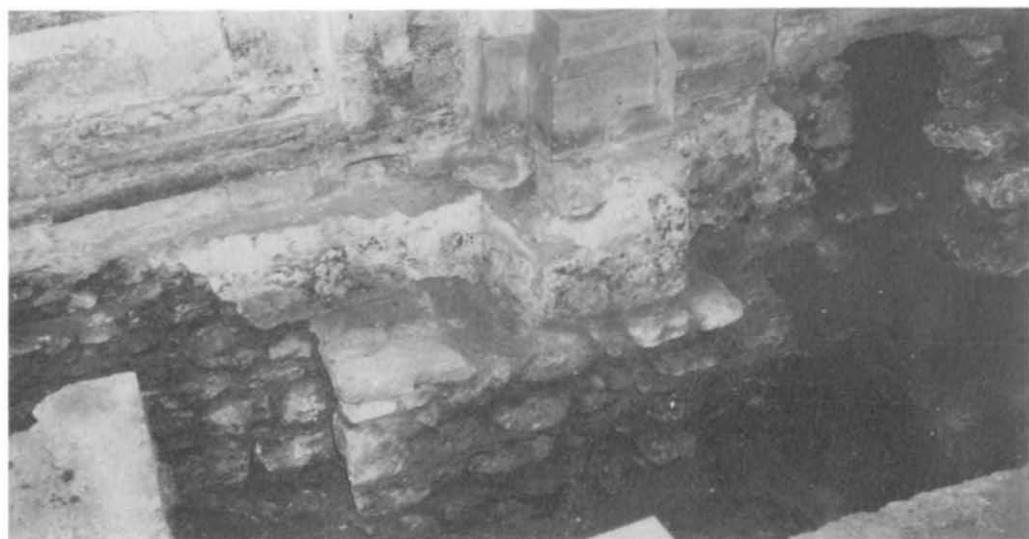
Fig. 41. S. face of cutting 2W, showing base of shaft II.4.F above plastered face (2W.J) and corner of early footing (2W.L).

M. Rubble corner of a foundation (Fig. 41), exposed to a depth of five courses or 65 cm. below the floor 4, projecting 38 cm. N. of the footing K(ii) which abuts on it. The trench-built N. face of the footing remained for a length of 1.5 m. westwards from this corner. Exposed for a further 2.6 m. westwards was a rough footing of small rubble, interpreted here as the same structure but with its facing robbed away at some date before the construction of the wall-bench F, which ran above it. If K(ii) was indeed late 12th-century, L may be identified as the corner of the N.E. transeptal chapel of an earlier 12th-century church.

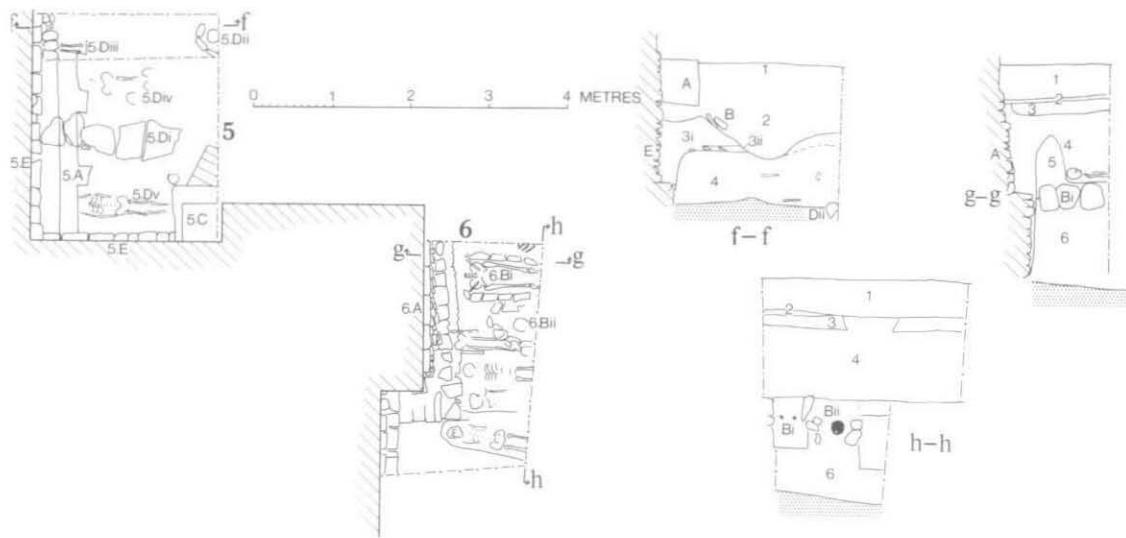
Fig. 42. Trenches outside E. end of Cathedral: plan and sections. (Re-drawn by John Blair.)

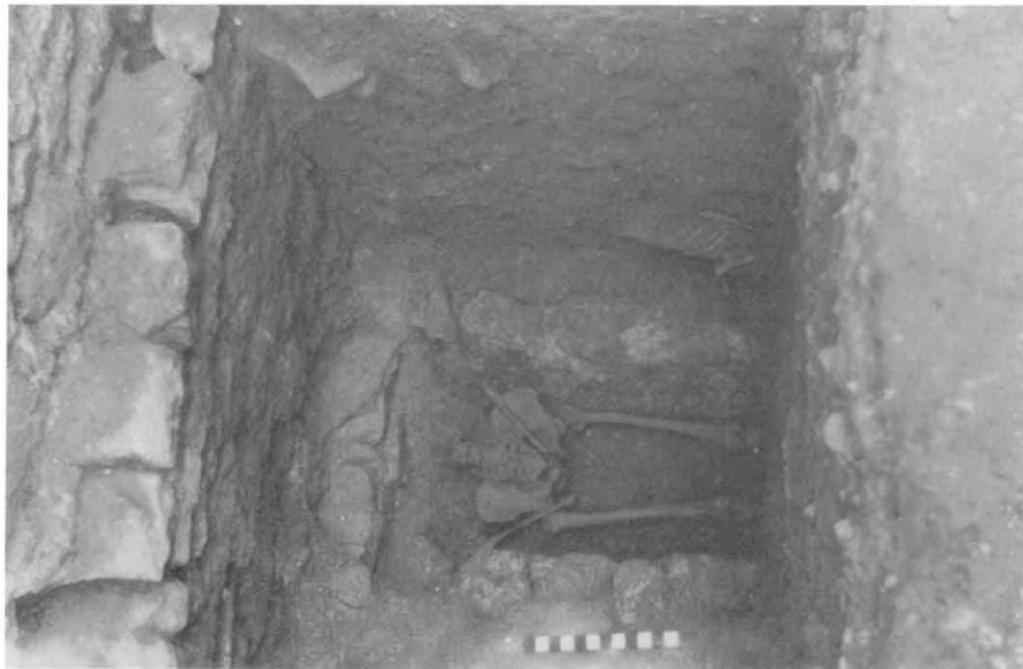
Fig. 43. Cutting 6, showing stone-lined burial (6.B.i) truncated by N.E. corner buttress of choir.

- Bi. The hips and thighs of a burial in a stone-lined grave, lying on very dark-brown loam or charcoal with a little gravel, cut through at the waist by the buttress-foundations (Fig. 43). Its lower legs remain E. of the cutting. The bones are those of an adult woman with no signs of extreme age (ex inf. Mary Harman).

The E. wall of the choir stands above a hollow dug nearly 2 m. into the natural topsoil and gravel, and filled with less compact material. This explains the very evident cracks above the windows either side of the high altar. The hollow may be a prehistoric ditch running, at this point, N.-S. (as the cracks are opposite each other), perhaps part of a Neolithic causewayed camp. The filling of the ditch, Layer 6, was gravel without much extra material. Layer 5 represented a redeposited loam, bringing the area up, perhaps still in prehistoric times, to a fairly even level, being very similar to Layer 4 in Cutting 5, which had not, however, been removed and brought back, as this must have been. The main medieval churchyard-deposit, Layer 4, was very like its continuation, as Layer 4, in Cutting 4. A Regency or early-Victorian carriage-drive, Layer 3, was covered with mortar, Layer 2, doubtless of George Gilbert Scott's works while reconstructing the E. windows of the choir above, while the late-Victorian and modern flower-bed topsoil, Layer 1, has brought the ground-level up to cover the lower plinth of the buttress, always, for some reason, left incomplete.

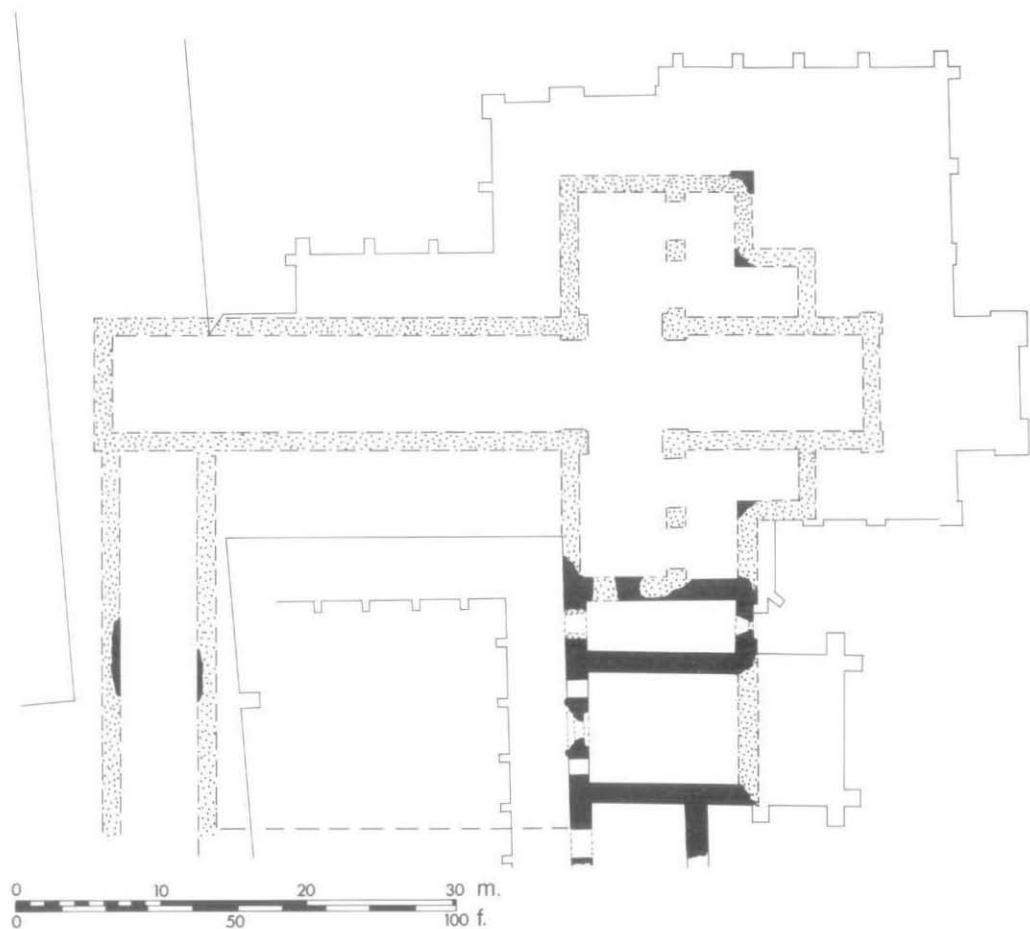
Fig. 43A. Ground-plan of the early 12th-century Augustinian church: Sturdy hypothesis.

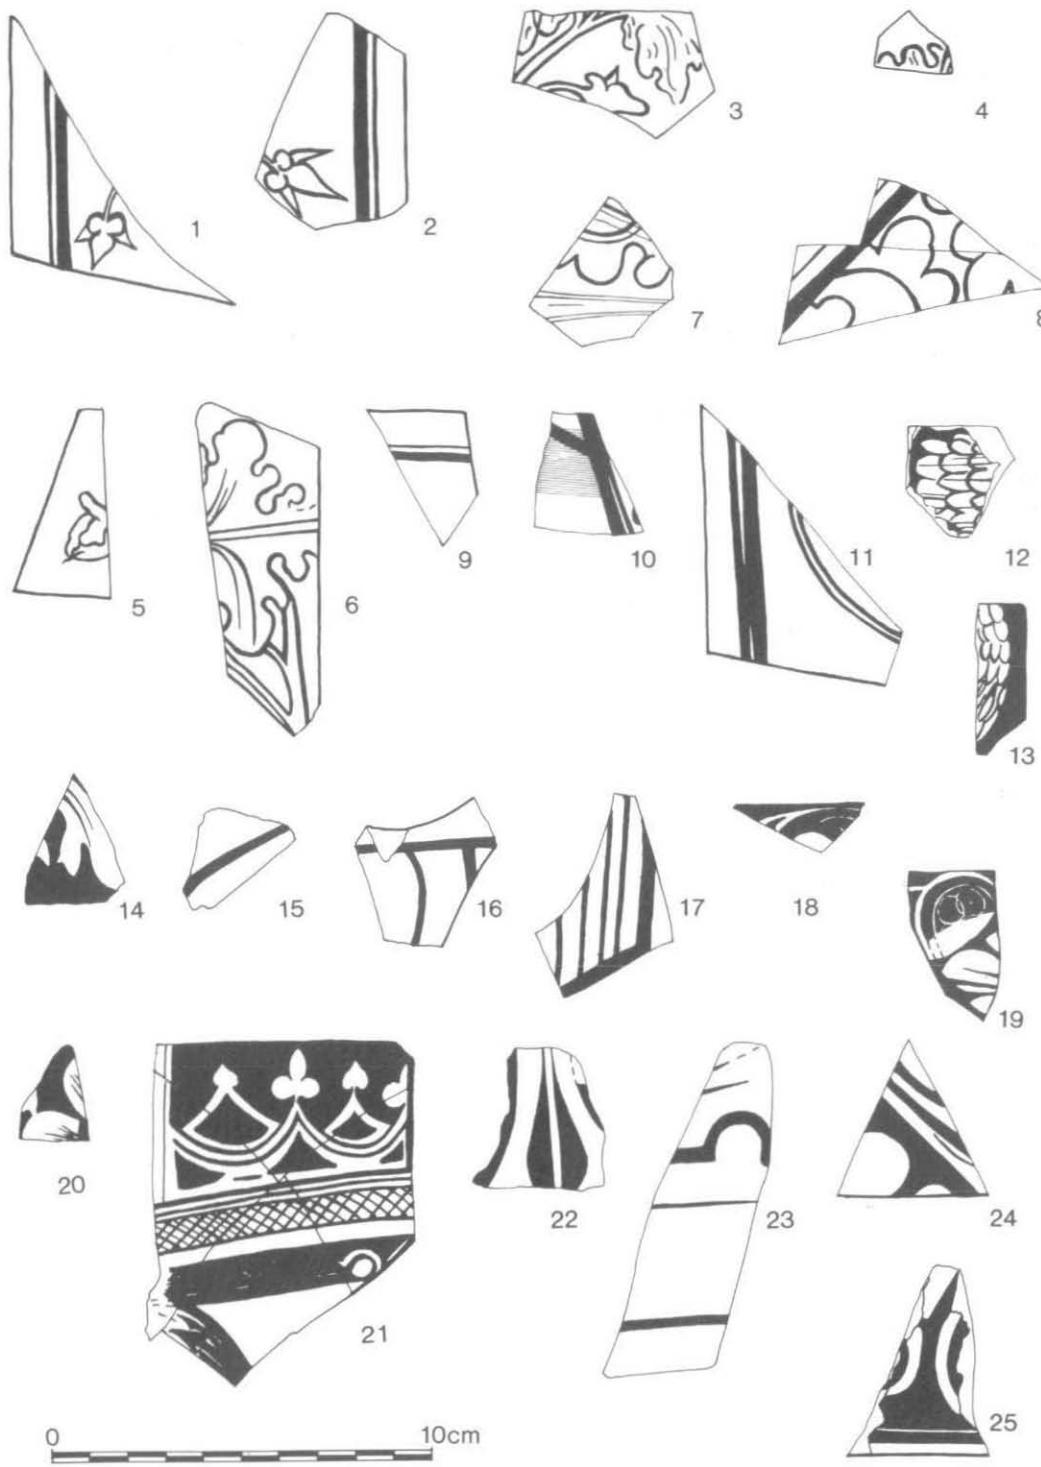
Fig. 45. Latin Chapel: excavated glass fragments. Scale 1:2.

Fig. 45 Nos. 1–11 depict the glass from the grisaille trellises of the three windows. Nos. 5–6 can be attributed to the archbishop saint window and 1–2 to the Virgin and Child window. Nos. 3–4 can also be attributed to the last, but with less certainty. However, the slight variations in patterning may only be apparent due to the restoration work. Each quarry in the trellis of each window has a narrow border of yellow stain delineated on the inner side by two parallel painted lines, one thick and one thin. The St. Frideswide window has trails of roses, the archbishop saint trails of daisies and the Virgin and Child oak-leaves and acorns as the grisaille design.
