# The Thames Crossing at Oxford: Archaeological Studies 1979-82

#### By BRIAN DURHAM

#### SUMMARY

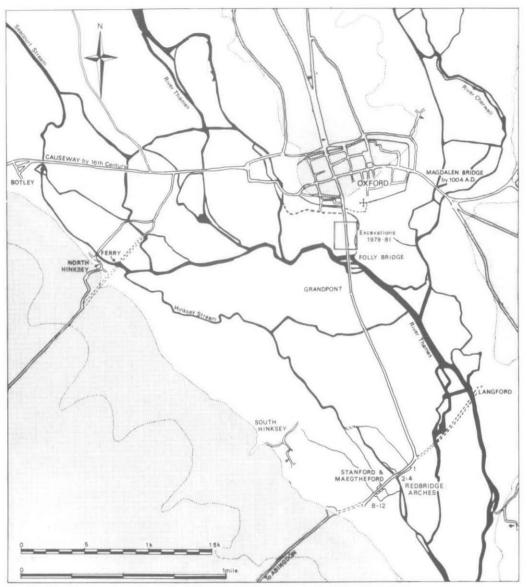
Fig. 1. The Thames and Cherwell at Oxford, showing the principal river crossings.

This was not the only ford on the Saxon crossing, since at least two others are known from charter evidence (Stanford, Maegtheford,<sup>18</sup> see Fig. 1), and there must have been either a ford or bridge at the Trill Mill stream.<sup>49</sup> The several streams of the Thames are distributed over a total valley crossing of 2.7 km. In many places the trackway would have been on gravel islands above flood level,<sup>50</sup> but an embankment might be expected on any low-lying stretch. The bank found previously under St. Aldates has been the subject of prolonged dispute,<sup>51</sup> and the writer is grateful to his collegues George Lambrick and Mark Robinson for their contribution to this report which clarifies the alternative approach (see above, 'The Middle Saxon Causeway?').<sup>52</sup> They make the important point that the bank material was alluvium, not Oxford Clay. This does not disprove the embankment thesis, however, since it was always assumed that the clay had come from the line of the Trill Mill Stream to the north, and it is known from recent excavations that this would in fact not produce Oxford Clay but a pale blue clay silt just like the bank material.<sup>53</sup>

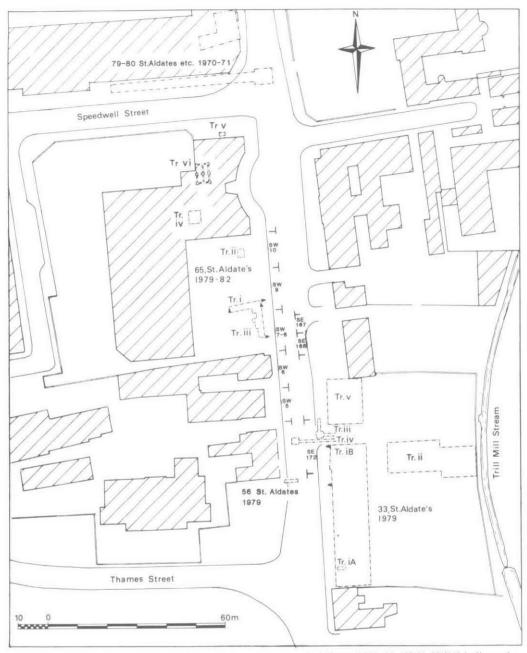
Fig. 2. Location of archaeological and contractor's trenches in St Aldates, 1970-82. 'SW5-SW10' indicate the revision of H.E. Salter's tenement boundaries based on excavated evidence.

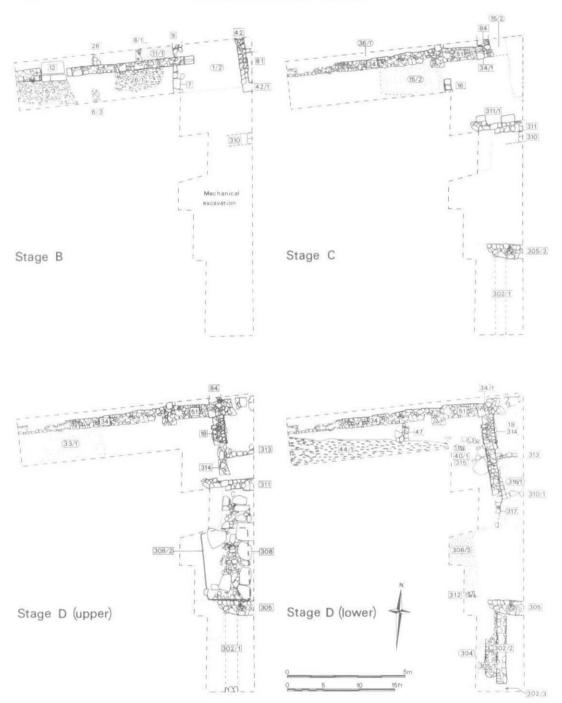
Fig. 3 65 St. Aldates Trenches 1 and III, plans in sequence of excavation. Stage B: Phase 7, c. 1770-c. 1860; Stage C: Phase 6, c. 1650-1770; Stage D: (upper levels): Phase 5b, c. 1450-1650; Stage D (lower levels): Phase 5a, mid 14th to mid 15th centuries.

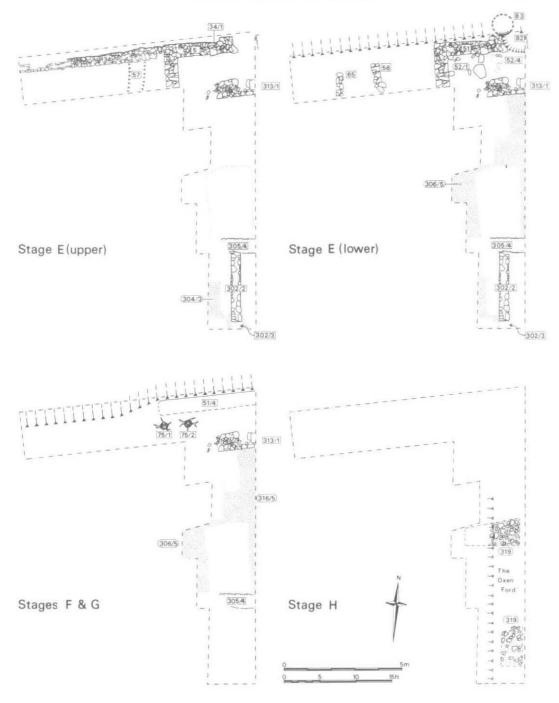
Fig. 4. 65 St. Aldates Trenches I and III cont'd Stage E (upper levels): Phase 4b, first half 14th century; Stage E (lower levels): Phase 4a, second half of 13th century; Stages F and G: Phases 3 and 2b in the first half of 13th century; Stage H, showing the late Saxon ford.

#### Phase 1: the 10th- to 11th-century ford and causeway (Figs. 4H, 5, 14)

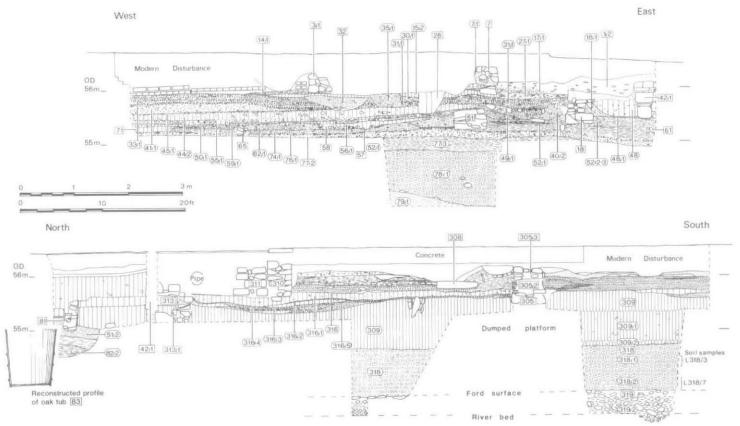
Fig. 5. 65 St. Aldates. Above: south section of Trench I (reversed); below: east sections of Trenches I and III combined, with profile of F83 projected.

The whole purpose of the project was to get a convincing answer to the question of whether there was an embanked Thames crossing at Oxford in the late 8th century.<sup>45</sup> There was, therefore, some disappointment when the end of the project was in sight and no substantial pre-Conquest levels had been found. The reason was clear enough: the excavation areas were on river channels and the causeway had either never existed or had been swept away as the river changed its course. Revelation came with the first deep 'sondage' on the street frontage at 65 Trench III, which was intended to provide a date for the silts of the underlying channel, but instead came down onto stone paving (L319). The quality of organic preservation indicated that this metalling had always been below river level, and paving of a river-bed logically meant a 'ford'.<sup>46</sup> This has since been confirmed by environmental studies (see above, Environmental Aspects), and the few sherds of pottery support the stratigraphic evidence that it must have been Late Saxon (see Figs. 5, 14). The absence of the causeway was therefore explained.

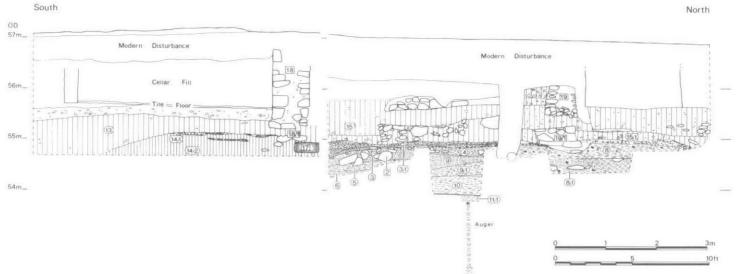
Fig. 6. 33 St. Aldate's: west section of Trench 1B showing progressive infill of a river channel to the south.

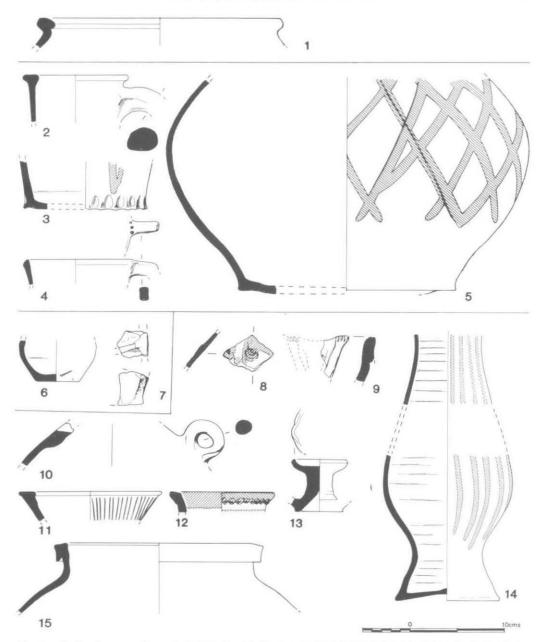
Fig. 7. Medieval pottery: Phase 2b 1. P77/3/1, CG; Phase 3: 2. P74/1/1 ZZ; 3. P77/2/1 ZZ; 4. P72/1/1, AW; 5. P74/1/2, AM; Phase 4a: 6. P51/3/1, AP; 7. P51/1/1, AM; Phase 4b: 8. P56/1/2, AM; 9. P52/1/1 AM; 10. P55/0/2, AM; 11. P56/1/1, AM; 12. P59/1/2, AG; 13. P55/0/1, AM; 14. P56/1/3, AM; 15. P59/1/1, AW.

occupation on the bridge frontage produced a vessel in a new shelly fabric (CG), and in the following phase came a Brill-type pitcher larger than any known from Oxford (17.5 litres, nearly 4 gallons incomplete, Fig. 7 No. 5).

By Phase 4 the flowering of the Brill industry was shown with the first of two anthropomorphic pieces from the site (Fig. 7 No. 9). The second example from Phase 5a is suggested as also being of late 13th to 14th century manufacture, interesting in that it combines the anthropomorphic modelling with a French-inspired 'parrot-beak' type of spout (Fig. 8 No. 7).<sup>23</sup> But returning to Phase 4, mention should be made of the condiment dish (Fig. 7 No 7). Fragments of this vessel were scattered through various levels of this and the following phase. The illustrated sherd is from Phase 4a, but is believed to be intrusive, and it is likely that the vessel belongs to the first half of the 14th century (Phase 4b).

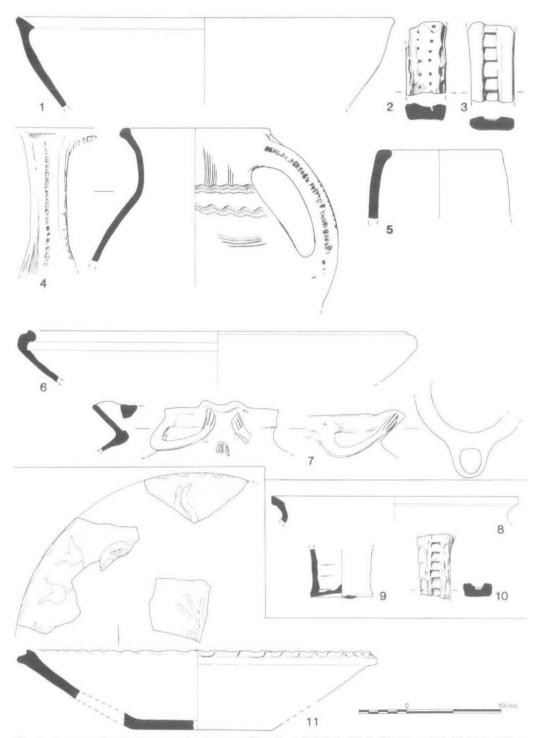
Fig. 8. Later medieval and post-medieval pottery. Phase 5a: 1. P70/2/1, AM; 2. P40/2/1, AM; 3. P44/3/1, AM; 4. P315/0/2, AQ; 5. P306/3/1, ZZ; 6. P40/2/1, AQ; 7. P315/0/1, AM; Phase 5b: 8. P36/3/1, AM; 9. P36/3/2, AM; 10. P33/1/1, AW; Phase 7: P1/2/1, DG.

Phase 5 adds several vessel forms of the late 14th to 15th centuries which are new to the Oxford 'collection', particularly a wide-mouthed bowl (Fig. 8 No. 1) and strap handles showing a new decorative style (Fig. 8 Nos. 2, 3). It is likely that this trend of new additions to the later medieval catalogue will continue slowly until we find a site with well-preserved levels of this period.

(Fig. 8, No. 7). The emergence of the name Broadgates under the Oseney property in the late 14th century is taken to mean that there was a wide entry on the frontage, and within the arbitrary documentary framework this can only mean that the bridge arch had been finally blocked, the parapet removed and a ramp created down onto the old channel bed.<sup>92</sup> Thus the Oseney tenement had now extended both north and south.

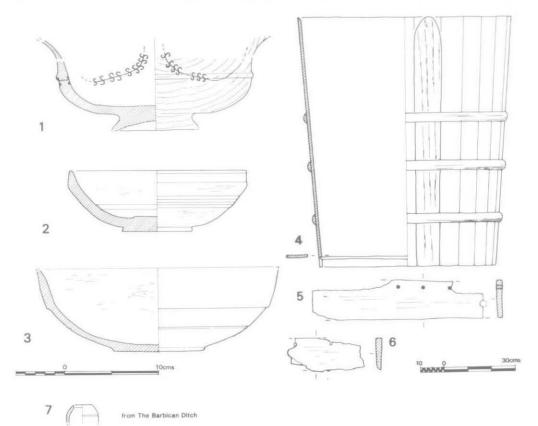
Fig. 11. 1–4, late 13th century wooden vessels ( $\frac{1}{4}$ ); 5, 6 planks with dowels and nail holes, possibly late Saxon ( $\frac{1}{16}$ ); 7. small cup or jar from Oxford Castle, east barbican ditch ( $\frac{1}{4}$ ).

Fragments of three wooden bowls were recovered from a 'culvert' at the edge of the excavation area. One bowl was in very poor condition (No. 3). The others were much better preserved, both contriving to give the impression of quality in their finely finished rims, though with thicker bodies. No. 2 was decorated with lathe-cut grooves, No. 1 with a wide band of relief around the girth to complement the out-turned rim and high footring. The especial value of No. 1 is indicated by an elaborate repair method which is so far unique. S-shaped pieces of bronze ribbon had been pushed into the end-grain along the line of a crack, on both the inside and outside surface. Other less complex methods of repairing wooden vessels are known from the archaeological record, (see Fiche E04) but the present example is likely to have combined strength with an enhanced appearance.

When the culvert went out of use, it seems to have been partially blocked by the staves of an oak tub set in the silts of the adjoining river channel. The excavator believed that the vessel was intact, although inaccessibly deep below a corner of the excavation so that only one of the six visible staves could be recovered. Use as a storage tank for live fish is suggested, but an alternative function as a water source is also discussed under the relevant phase (Discussion and Interpretation Phase 4a)

The fiche report includes a note on No. 7, a fragment of a very small lathe-turned

cup or jar from the east barbican ditch of Oxford Castle, which has not previously been illustrated.

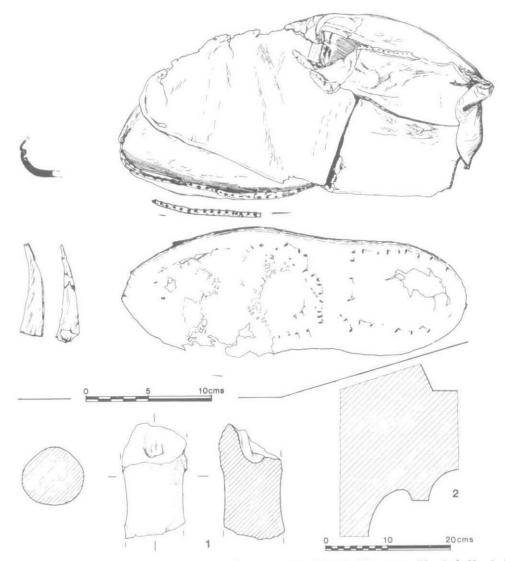
Fig. 13. Above: early 13th-century leather shoe ( $\frac{1}{3}$ ) (Fiche E09); below: building stone (No. 1,  $\frac{1}{3}$ ; No. 2,  $\frac{1}{6}$ ) (Fiche E11).

Only two of the seven items of Late Saxon and medieval leather showed signs of working. The illustrated shoe (Fig. 13) was typical of local early 13th-century construction, with a rand in the sole-upper seam. It was uncertain whether it was a left or right foot.

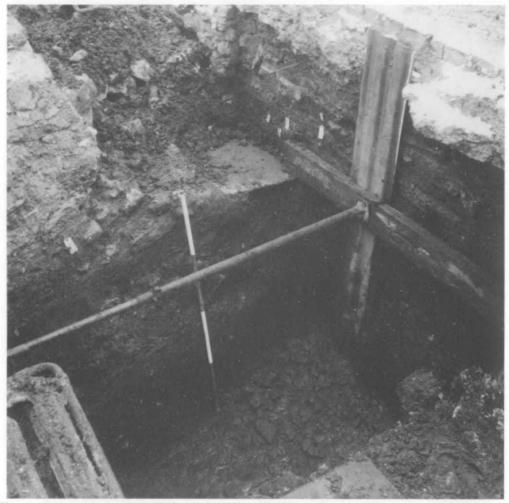
Plate 1. Paving of the late Saxon ford at 65 St. Aldates III. The ranging pole illustrates 1 m. depth of river silt blanketting the ford, with a further 0.8 m. dumped platform above.

sondage. The surface was composed of small (100–150 mm.) slabs of Corallian stone, laid flat but heavily abraded on all faces as though they had been rolled (Plate 1). The archaeological trench had been placed as close as practicable to the modern street, but the body of the ford must be further out, and on the assumption that the Norman stone bridge was built along its downstream edge it has been conjectured as c. 7 m. wide. The excavated margin may therefore be an addition, not representative of the main construction, and this would explain the relatively late radiocarbon date of A.D. 980–1040 years from wattle fragments sealed within the structure (HAR 5340 corrected, see Table 1).

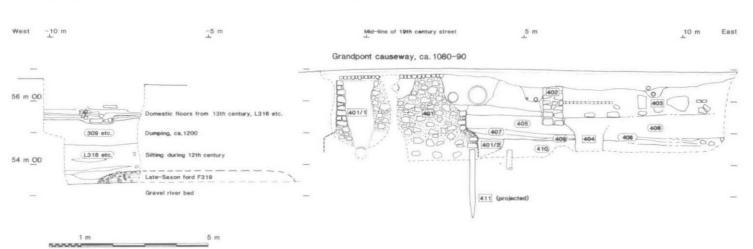
Fig. 14. Right: section through Norman causeway and its downstream frontage at 33 St. Aldates IV; left: section of the Saxon ford at 65 St. Aldates, projected to show its presumed relationship to the stone causeway which replaced it.

The reconstructed profile of the ford in Fig. 14 is therefore somewhat imaginative, and there is even less evidence for its overall length. The gravel riverbed at 65 Trench III had given way southwards to an 'alluvial island' at 33 Trench IB, so the ford probably did not extend more than about 35 m. in this direction. Towards the town there are no sightings of sufficient depth, but there can be little doubt that it started from the north bank of the

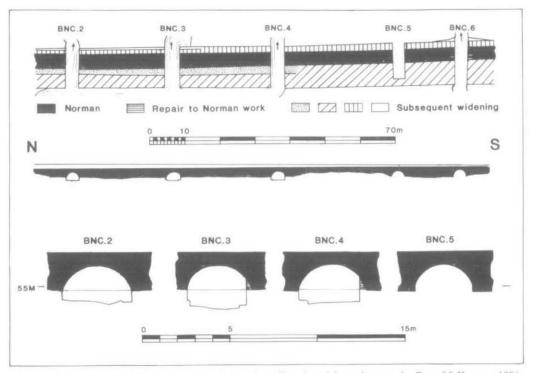
Fig. 15. Survey of Grand Pont arches BNC 2-6 with profiles viewed from the west, by Peter McKeague, 1984.

The 4 m. wide ragstone causeway at 33 St. Aldates finds an echo in the open arches south of Folly Bridge (Fig. 16, arches BNC 2–4). They show that the road has been widened three times, and Peter McKeague's survey has shown that the earliest component was the ragstone vault second from the east in each case, with widths between 3.9 and 4 m. (Fig. 15, Fiche CO2).<sup>64</sup> If this is the same structure as at 33 St. Aldates it is already 260 m.

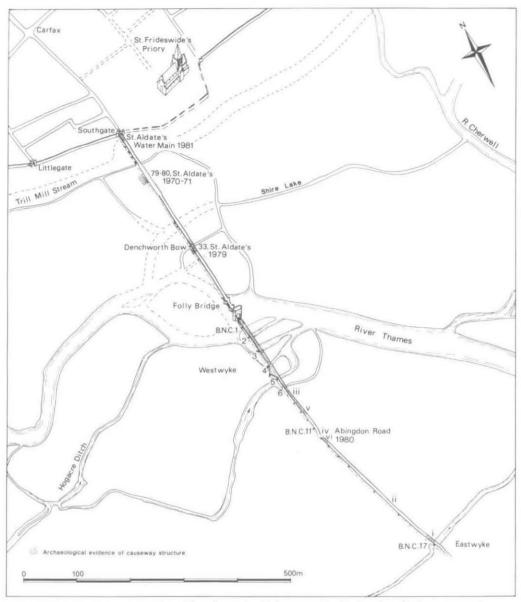
Fig. 16. Axonometric reconstruction of Grandpont *circa* 13th century showing location of salvage excavations etc. BNC 1-17 are flood-arches depicted on Brasenose College map of the 16th century.

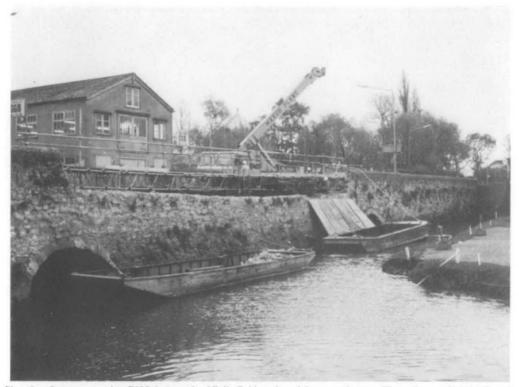
Plate 2. Causeway arches BNG 2-4 south of Folly Bridge viewed from north-west. The collapse of 1980 affected only the c. 18th-century stone skin of the second western widening, the Norman work being well protected in the core of the causeway.

and 3 had collapsed in 1980. The skin of course is the second widening on this side, built after the mid 17th century (clay pipe bowl) but before the blocking of BNC 1 by the pound-lock arch of  $1821.^{s_1}$

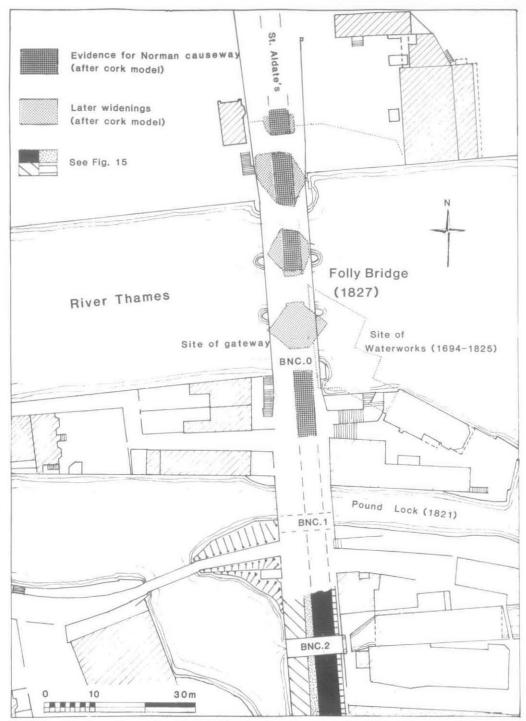
Fig. 16A. Location of the medieval Folly Bridge, based on the cock model which seems to have been made c. 1815-25, before or during demolition (Ashmolean Museum 1878.272). The above reconstruction assumes the model was at a scale of <sup>3</sup>/<sub>16</sub> inch to 1 foot (1:64) and embodies conclusions from a scale drawing of the model kindly provided by David Sturdy.

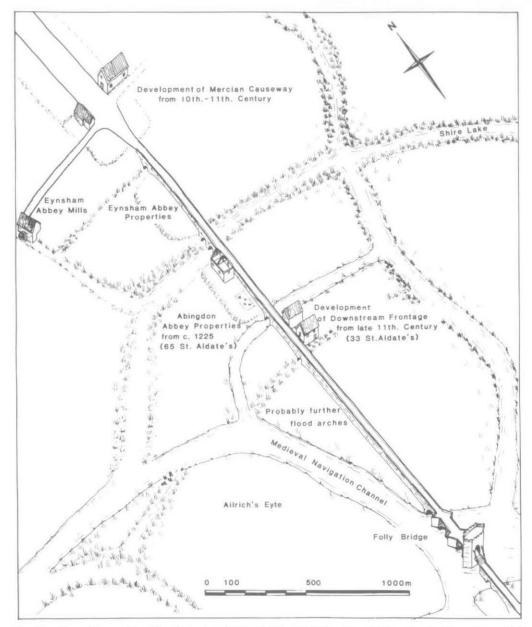
Fig. 17. Part of the parish of St. Michael at the Southgate *circa* 1225: axonometric reconstruction of excavated plots illustrating the main phases of development of the Grandpont frontage.

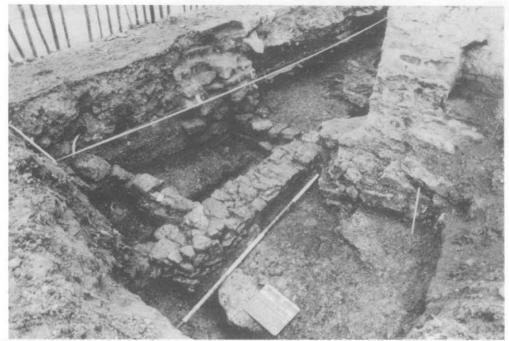
Plate 3. 65 St. Aldates Trench III from north-west, showing Thomas de Leigh's Phase 5 rebuild of the Oseney tenement by 1345. The double wall in the frontage section and the modern garage footing (right) illustrate how de Leigh's enlargement of SW9 has been perpetuated.

rear wall (F18, F314) bridged the old boundary (F313) and extended 2 m. over the floors of its neighbour. A slender partition wall divided the two properties now, insignificant in itself (F310/1), but the precursor of two very solid stone walls which were to define the two properties into the 20th century (F310, F311). So although it is not absolutely certain that the primary wall F313/1 functioned as a property division in the previous phases, there is no doubt that the modern boundary arose out of nothing, across the floor of a room, more than a century after the first settlement of the platform.
