The Binsey Boat: a post-medieval story of the Thames at Port Meadow, Oxford

By BRIAN DURHAM, REBECCA BRISCOE and COLIN MCKEWAN

This report describes a small scale rescue of part of a boat subject to river erosion, with quite unexpected implications for three areas of enquiry: the evolution of the Oxford Thames from commercial waterway to leisure activities; the challenge of reconstructing a possibly unique river craft from small areas of its inner hull; and reflections on the geomorphology of one of the most closely studied flood plains in England. The story started in 2003 when cabling works on the east bank of the Thames at Medley exposed a boat eroding from the bank, notified to Oxford City Council's archaeologist. The boat was of clench bolt construction and its exposed remains presented a risk to bathers, stock and navigation. In the context of Port Meadow's protected status and the uncertain age of the vessel it was clear that any investigation would have to be a carefully designed so as not to compromise the vessel or its surroundings.

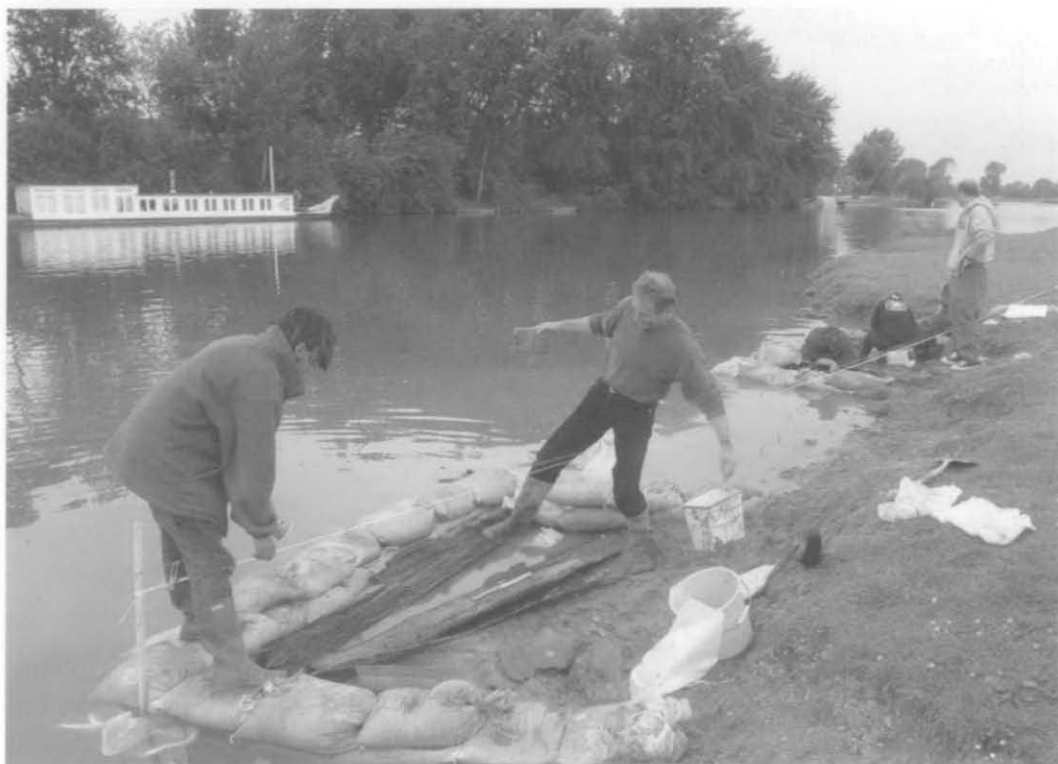
Fig. 2. View north (upriver) with cofferdams protecting Trenches 1 to 3 under excavation. Moored opposite is the Queen's College Barge.

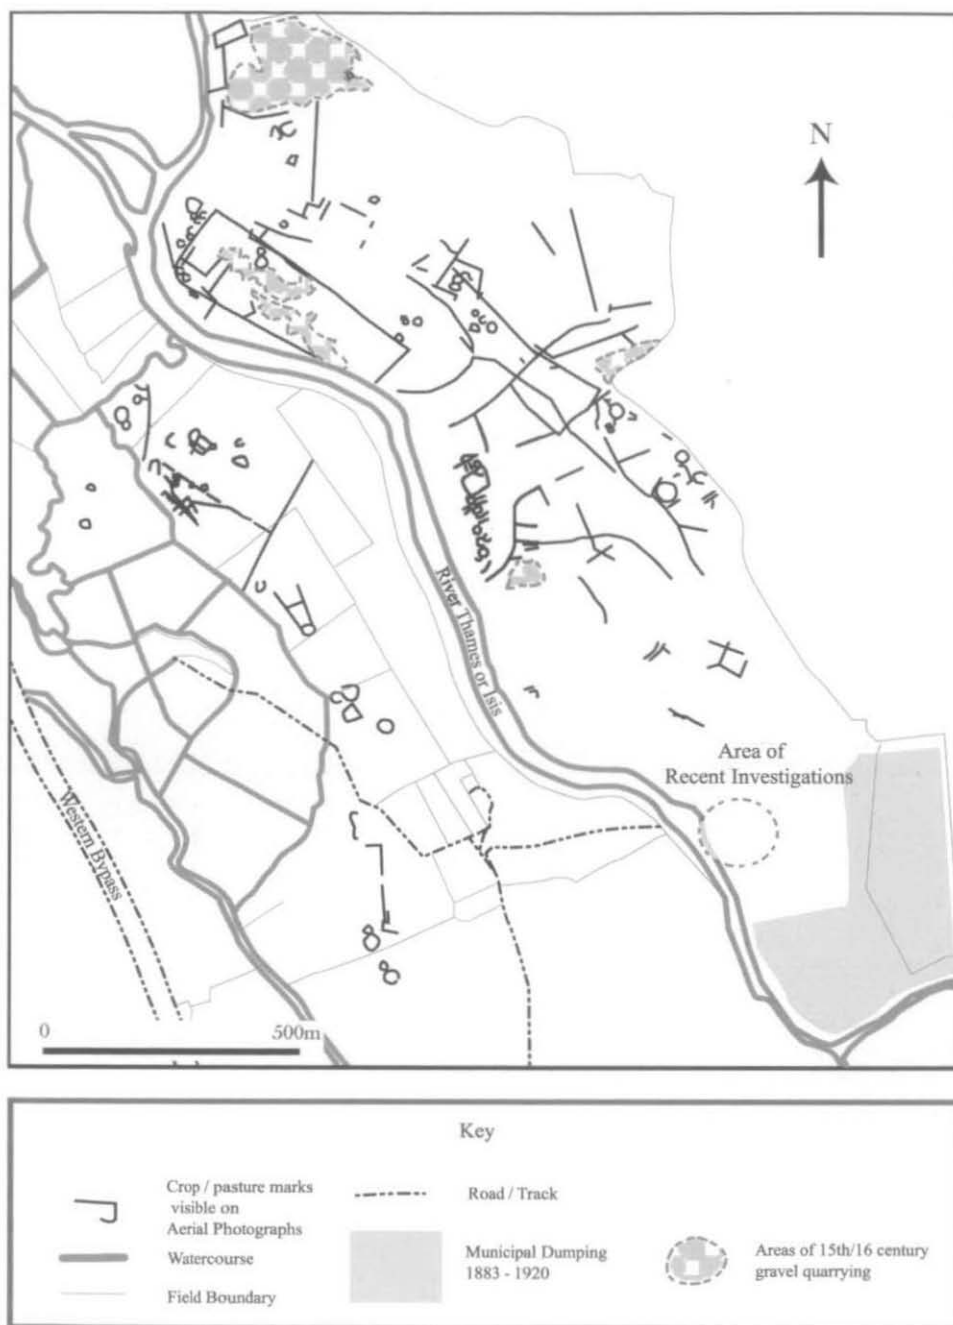
Fig. 3. Cropmark plot of Port Meadow and Binsey, after Lambrick and McDonald, *op. cit.* note 1, Fig. 2)

The biggest anthropogenic impact on the topology of the meadow (besides the crop/grass mark evidence discussed below) has arisen in the southern part of the meadow through municipal rubbish tipping between 1883 and 1920 (Fig. 3), which has significantly raised this part of the meadow above flood level. More recently ecological management has encouraged the silting of formerly active drainage channels to conserve the habitat of the endangered creeping marshwort (*Apium repens*).

County History's account.² The first datable features are the remains of at least six Bronze Age ring ditches (Fig. 3), probably flat disc barrows which vary in size from 10 to 30 metres in diameter. The largest of these, marked on the OS map as 'Round Hill', was excavated by Sheriff Hunt in 1842. The earthwork that remains today may be largely Hunt's reconstruction, and was further investigated, inconclusively, by T. E. Lawrence as a schoolboy.³ Also evident from the aerial photographs are a series of crop/grass marks relating to Middle Iron-Age farmsteads (Fig. 3), specialised pastoral sites closely related to the higher gravel terrace settlements nearby.⁴ Evidence of Roman and Saxon activity on the meadow is sparse, with only a small number of individual finds, including a Saxon spearhead.

Latterly, the biggest impact has been the military encampment of the Royal Flying Corps during the First World War, which remains visible as concrete platforms and latrine pits (Fig. 3) and less obviously in the continued existence of the pedestrian track from Walton Well Road to Medley Boat Station, built in 1860 but enhanced during the Second World War when a crashed Wellington bomber had to be rescued from the River. The southern and eastern parts of the meadow were also used as allotments from the First World War through to the 1960s, and as a municipal rubbish dump from 1883 to 1970, which was subsequently re-turfed. Currently the meadow provides a recreational area for walkers and pleasure boaters, along with seasonal ice-skating on the flooded stretches at the south of the meadow.

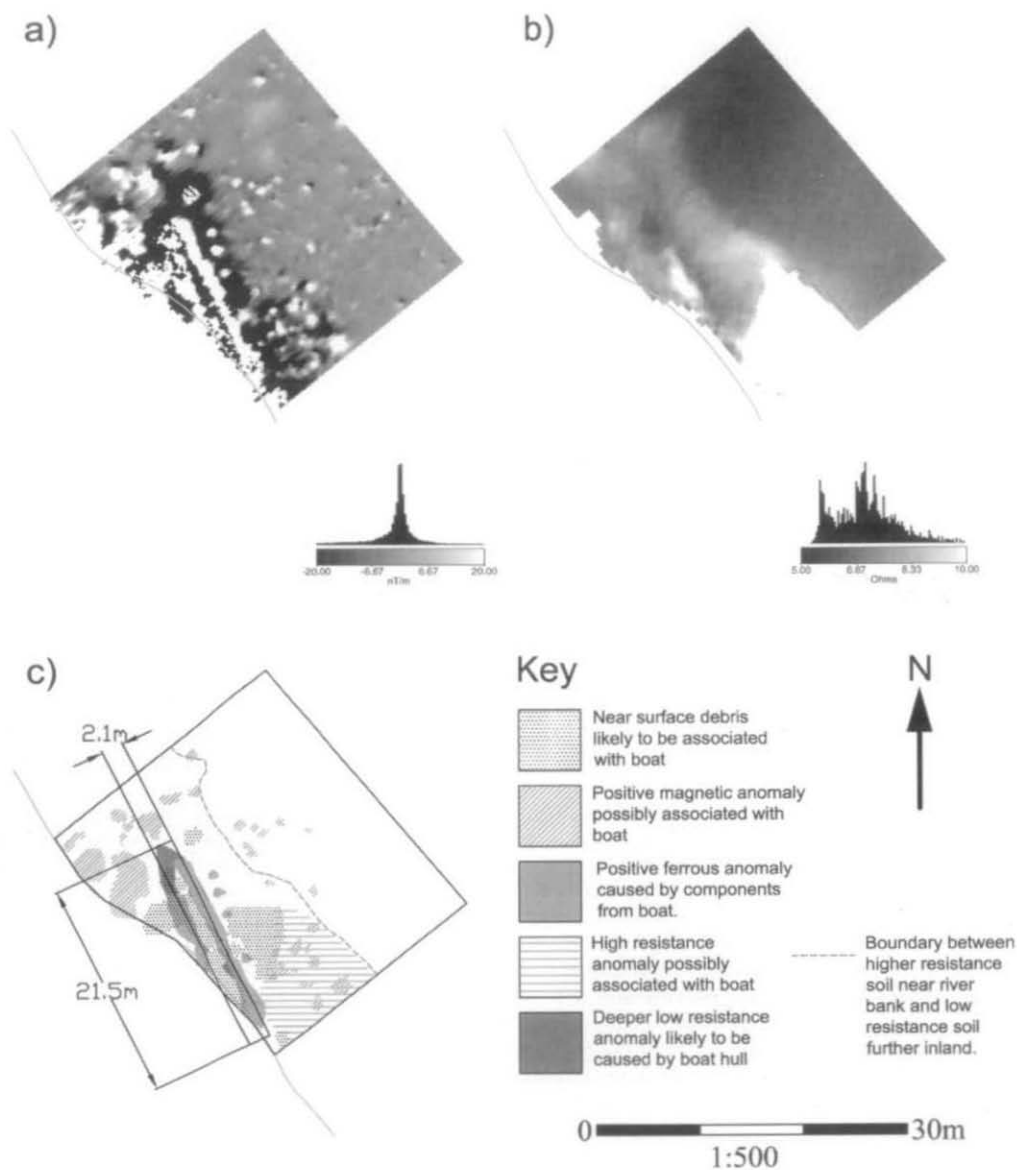
Fig. 8. Geophysical survey: a) magnetometer survey; b) earth resistance survey showing the results from the 0.5m mobile electrode separation measurements; c) interpretation of the geophysical anomalies showing approximate inferred dimensions of the boat.

The most striking feature of the magnetic survey are the two parallel linear anomalies indicated in Fig. 8a running almost N-S. They have peak magnetic gradients around 100 nT/m. and meet the river bank at the points where the two sides of the prow visible in the water emerge. A parallel line of four discrete anomalies of similar magnitude has also been detected and it is likely that they are all caused by ferrous material associated with the buried boat structure. Overlying the linear anomalies, several amorphous areas of steep rapidly varying magnetic gradients have been detected. These are characteristic of near-surface ferrous material and, given their positions, are likely to be caused by scatters of debris from the boat. The wider area is scattered with further discrete strongly magnetised responses with diameters between 0.5-1 m. and peak magnitudes in the range 30-100 nT/m. These are also likely to be caused by buried ferrous objects, possibly associated with the boat.

Two relatively deeply buried (~1 m.) parallel linear low resistance anomalies have also been detected running NNW from the river bank for about 17 m. before apparently converging. Although their interpretation is not entirely clear, the measurements suggest a tapered or rounded north end to the boat. These anomalies correlate with the two linear magnetic anomalies described above and it is likely that they are caused by the two sides of the hull of the boat. However, it is not possible to determine whether the material causing the increased electrical conductivity is metal or waterlogged wood. The electrical anomalies extend about 2 m. further at their NNW end than the longer of the two corresponding magnetic anomalies extending the estimate of the length of the buried portion of the

Magnetometer Survey (Fig. 8a)

Observation of the exposed part of the boat showed that ferrous material was likely to be found associated with it, hence an initial magnetometer survey was carried out using a Bartington Grad601B dual sensor fluxgate gradiometer to pinpoint the location of any buried remains. Traverses were separated by 0.25 m. with measurements taken at 0.125 m. intervals along each. The results are depicted in Fig. 8a, corrected for differences in the zero-offset of the two sensors by zeroing the median of each traverse. Slight shifting of each traverse to maximise correlation with its neighbours was also performed to compensate for variations in the operator's pace.²⁷

Readings were collected at 0.5 m. intervals along traverses spaced 0.5 m. apart for the former survey and at 0.5 m. intervals along traverses spaced 1.0 m. apart for the latter. Extreme values caused by high contact resistance were removed from both datasets using an adaptive thresholding median filter²⁸ with radius 1 m. and the results for the near surface 0.5 m. electrode separation survey are depicted as a linear greyscale plot in Fig. 8b.

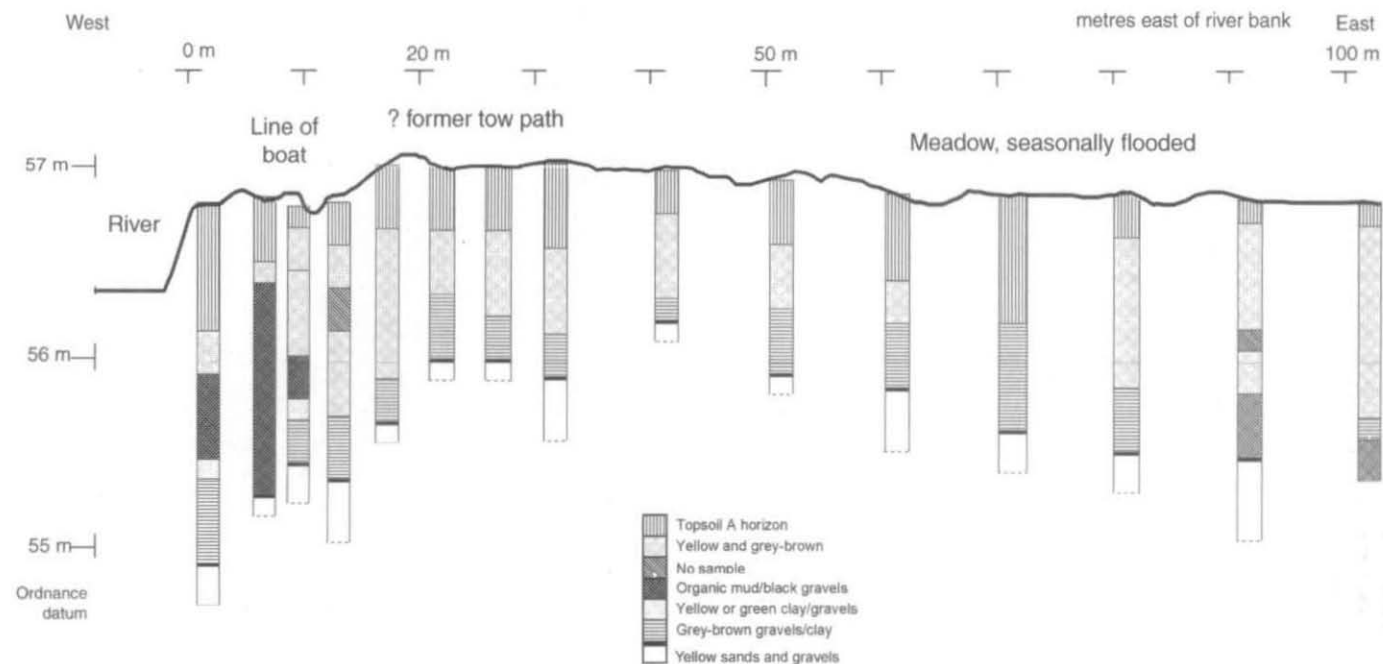
Fig. 16. Riverbank geoarchaeological Transect A.

Port Meadow, Oxford: geo-archaeological and environmental survey 2004, west-east, 2.5 m north of boat

Around the boat the augured profile shows (from top): a fine textured upper topsoil; an alluvial A horizon (0.3-0.5 m.); dark grey to black organic muds with fine gravel (0.2-0.6 m.). These have the character of an organic channel fill, which might (on further examination of the organic content) prove to be a reed bed at the edge of a slow moving part of the river. This appeared to match the dark organic

layer reported surrounding the boat (L 202.), but not found inside it. Inland of the boat this sequence ends between A/9m and A/12 m, perhaps indicating the Thames bank against which the boat had been moored or beached in shallow slow moving water. If so, this wedge of deposit has accumulated in at most 220 years, possibly accelerated by the presence of the boat remains and possibly other local obstructions (see below).

These presumed modern channel deposits overlie (from top): a variety of thin (<0.1 m.) alluvial layers (yellow sand, green clayey silt); a layer of grey to black clay and gravel (0.1 – 0.4 m.). The latter appears to cover the entire transect (although only black where it underlies organic muds), and presumably represents the pre-boat channel deposit. In turn it overlies a ubiquitous yellow sand and gravel layer, assumed to be the top of the geology of the flood plain, presumably resulting from periglacial deposition under much higher energy. It should however be noted that the coarser gravels underlying the river edge sequence have not been definitely related to the deeper gravels, and this might be addressed in future.

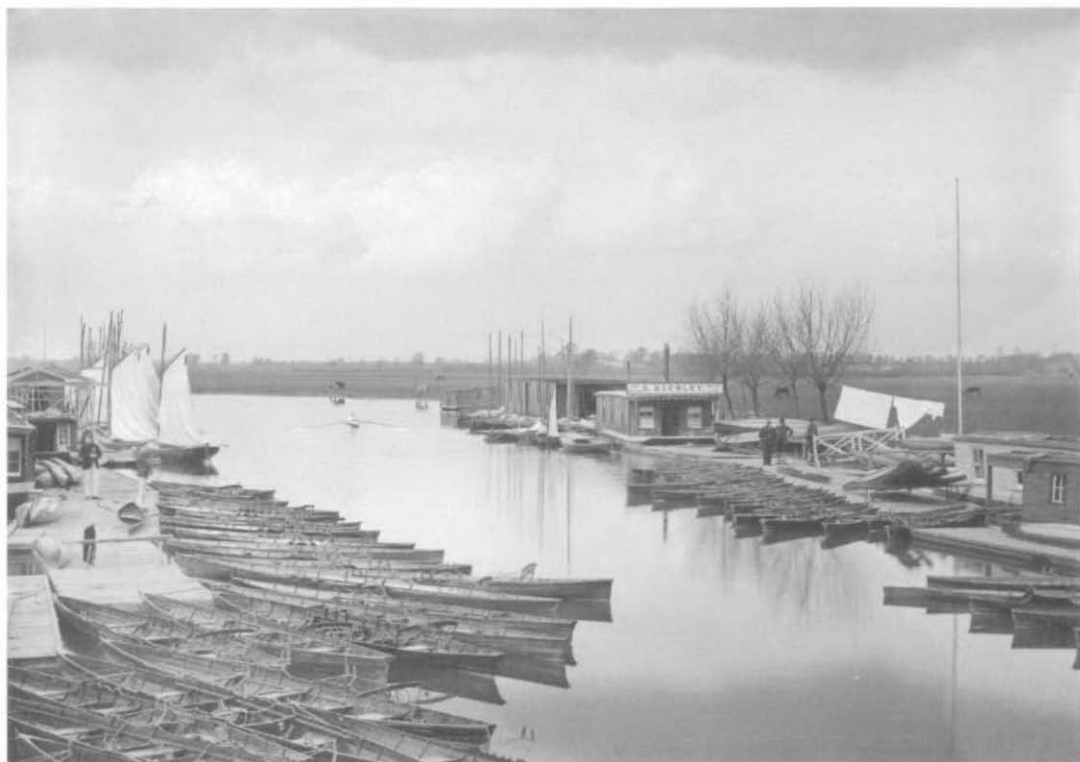
Fig. 19. Henry Taunt photograph of Medley weir stream mooring around 1880, showing offices of Beesley (right) and Bossom (left). Site of excavated boat would be beyond these moorings, with pale coloured grazing animal

¹⁹ Prior op. cit.; *VCH Oxon.* iv, 282, 428; Oxfordshire County Council CC72/02170, reproduced below Fig. 19; Hibbert op. cit., 342–3.
